Comparison of Characteristics, UCHIYA UI2 vs. Counterfeit

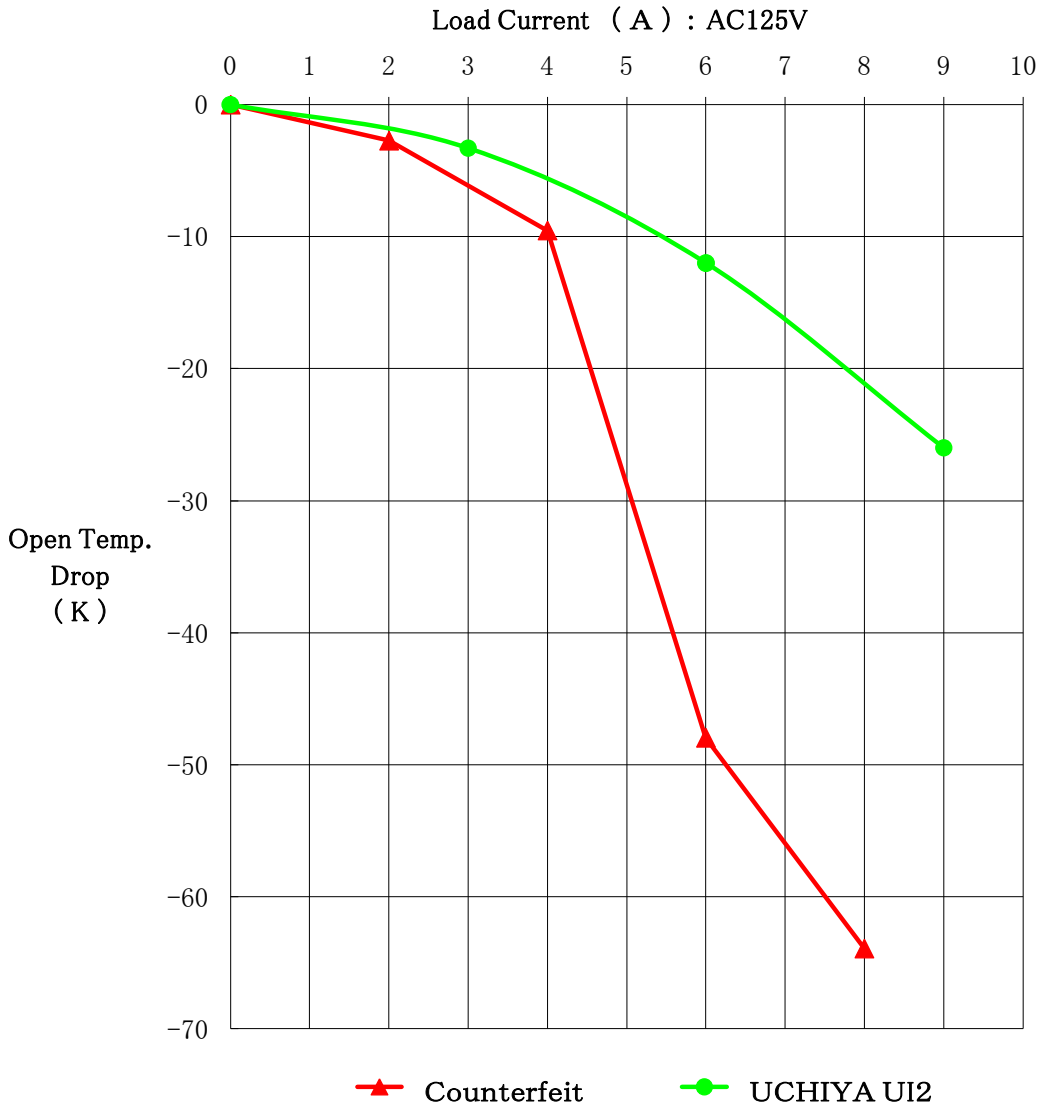
Open Temperature Drop against Load Current (Ampere)

Wrong operation of the counterfeit have been observed when we applied high load current of 6A and 8A to the counterfeit. (Please see the graph to the left.)

When use the counterfeit at load of 4A or above, it might cause wrong operation at lower temperature than intended.

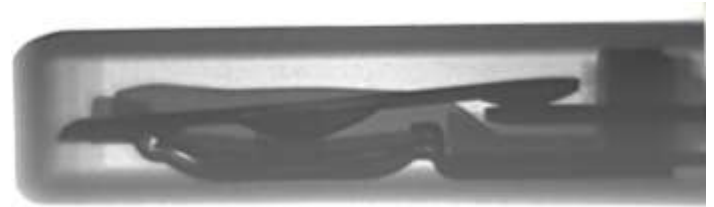
UCHIYA UI2

Inside Structure (X-ray)
